Winter Channel and Outlet Structure Inspection

Chisago Lakes Lake Improvement District

On February 4, 2011, an inspection of the Chisago Lakes Outlet Channel and Structures was conducted by Jerry Spetzman and Mary Christopherson. Due to snow cover, all areas of the channels were not able to be accessed. The following summarizes the inspection.

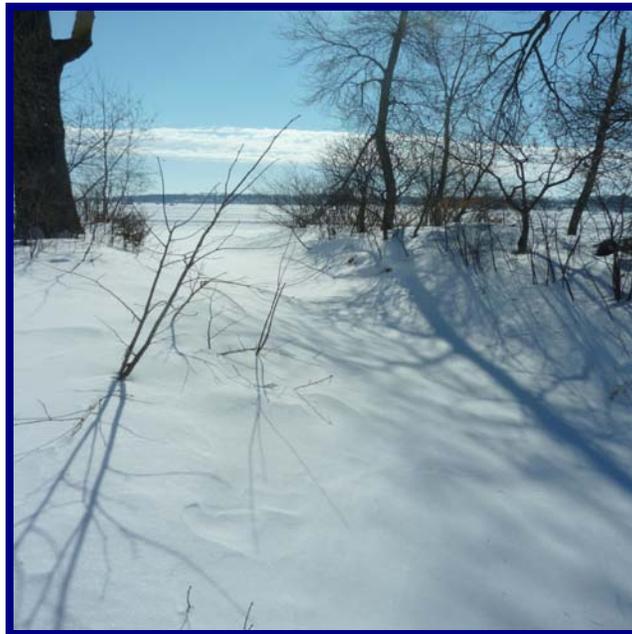
The channel from Chisago to Wallmark Lake was observed to be snow covered with no apparent beaver activity or water flow. The portion of the channel located adjacent to Paradise Park had received maintenance in the 2010 fall season.

Channel located adjacent to Paradise Park,
looking south to Chisago Lake.

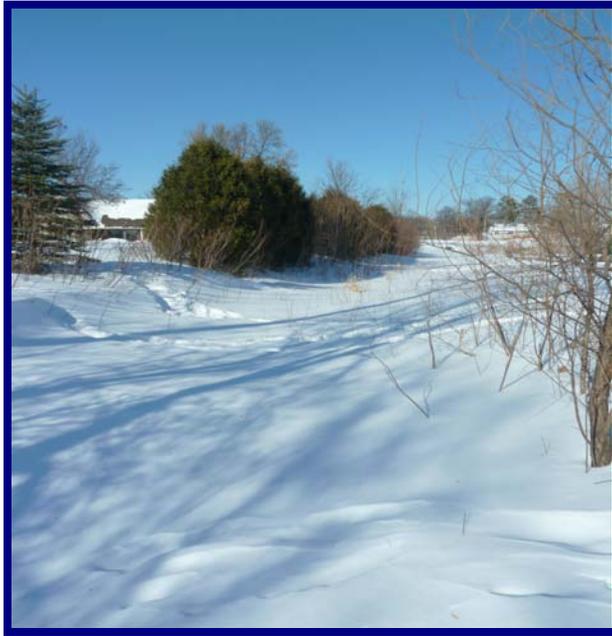
Channel located adjacent to Paradise Park,
looking north.

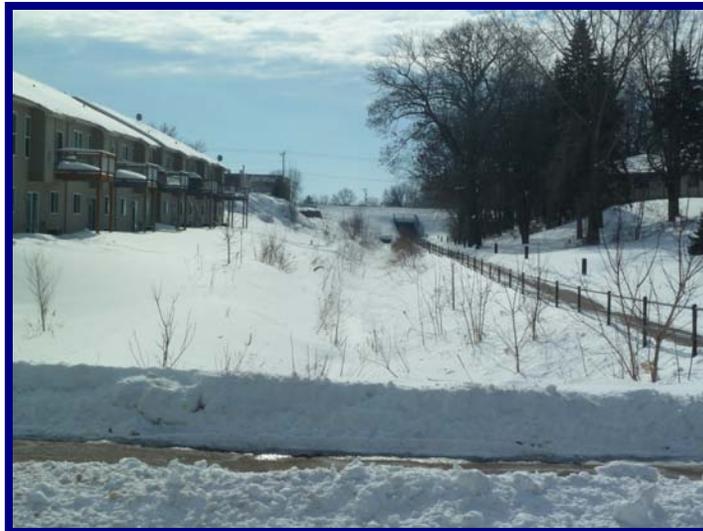
To investigate possible blockages in this culvert, causing the water to flow back into Chisago Lake instead of through to Wallmark Lake, a project will ensue in the spring of 2011. The culvert will be televised beginning on the south side of Stinson Avenue, through Chuckie Lindquist Park, and exiting the culvert located just north of Highway 8, adjacent to the bike trail.

Taken from North Avenue, looking south at the channel
located just north of Highway 8, adjacent to the bike trail.

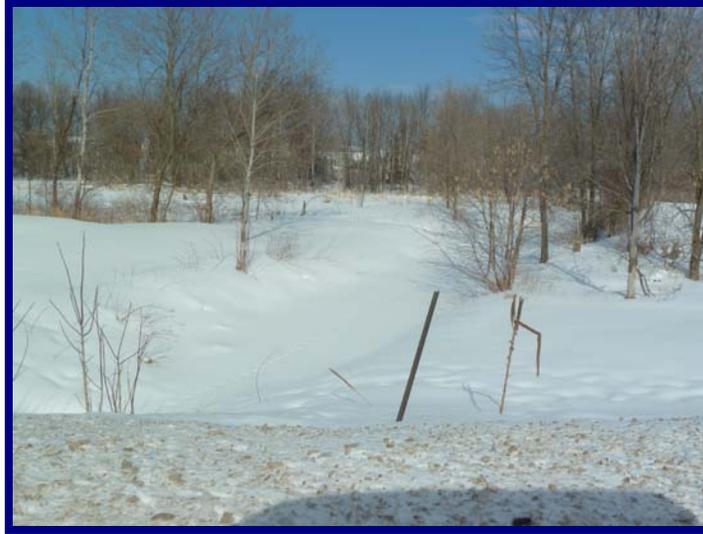
The portion of the channel located just north of North Avenue and west of Water Tower Park.

- 1) Investigate replacing a foot bridge over the channel adjacent to Water Tower Park; perhaps partner with Chisago City on this.
- 2) In the future, re-visit the need to survey the channel to determine why the water may be flowing the opposite way. (A previous survey proposal was not approved).

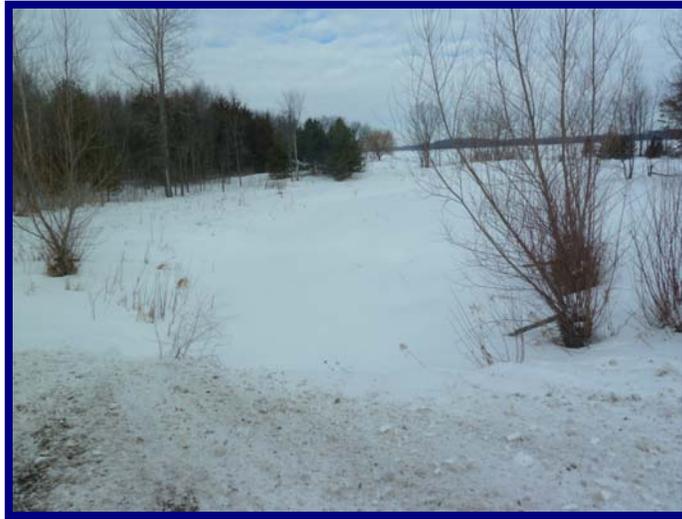
The channel on the Chisago Lake end was inspected. In the 2010 fall season, a beaver dam was removed from this portion of the channel. No beaver activity was observed during this inspection at this location.

Channel from Chisago Lake to Green Lake
(north of County Road 83).

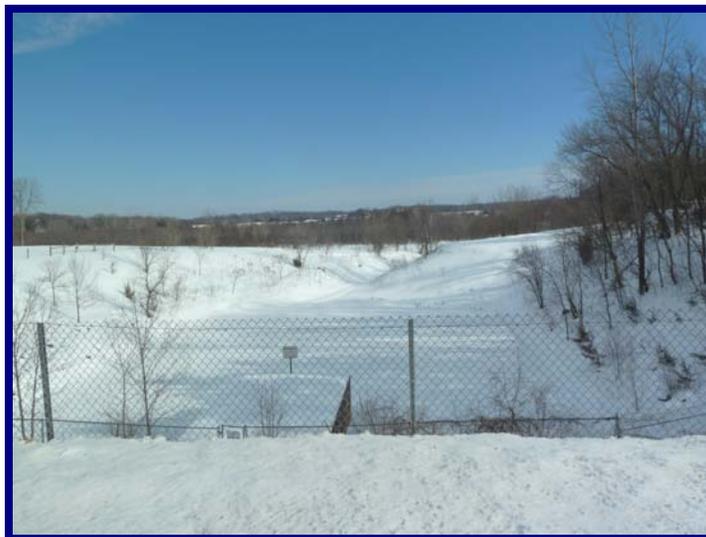
The weir structure at Lofton Avenue was inspected from the roadway. Deep snow prevented access to the weir structure itself.

Lofton Avenue weir structure, taken from
County Road 24.

- 1) Have additional tool made/ordered to operate weir gates, perhaps power-driven.
- 2) Exercise and grease weir gates.
- 3) Hang new undertow warning sign.

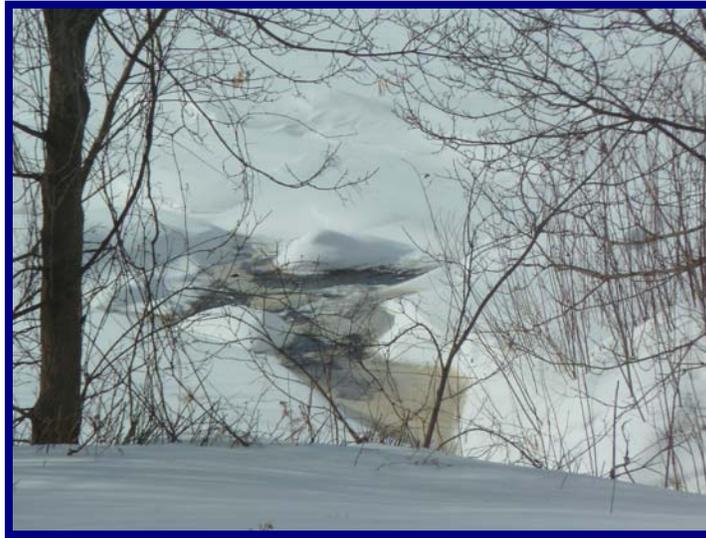
Water flowage was observed on the west side of County Road 24, apparently coming from the culvert connected to the Lofton Avenue weir.

Water flowage entering Green Lake observed on the west side of County Road 24.

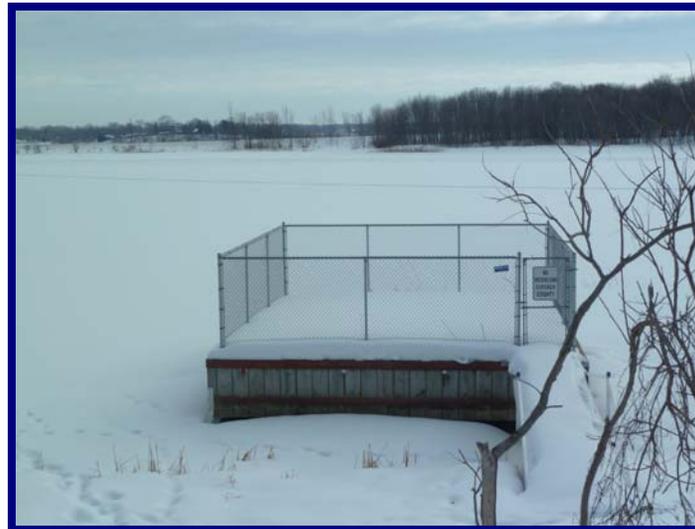
The area around the Lake Ellen weir structure was inspected. No animal tracks were observed around the perimeter of the structure. The structure was snow covered.

- 1) Have additional tool made/ordered to operate weir gates.
- 2) Exercise weir gates.
- 3) Hang new undertow warning sign.

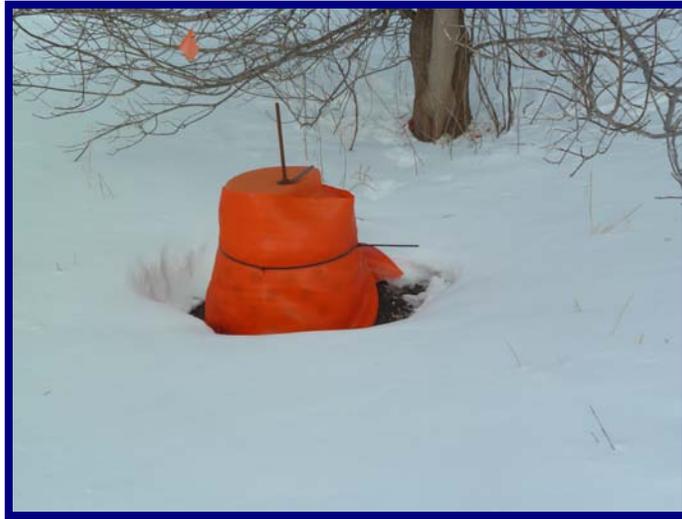
The manhole with an inlet structure located in the nearby farm field was also inspected. In the 2010 fall season, a sediment control device was placed on top of the inlet structure to limit sediment entering the long pipe below, which discharges to Swamp Lake. It was noted that the snow did not abut the sediment control device, perhaps due to geothermal heat from the deep pipe below.

Sediment control device on manhole in farm field.

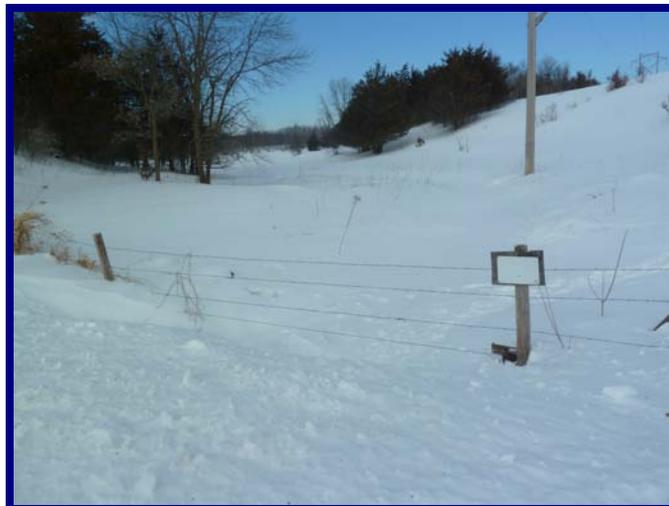
The Swamp Lake outlet pipes under County Road 80 were visited. The pipes on the north side of County Road 80 were observed to be snow covered. However, there did appear to be a small area of open water on the south side of County Road 80.

Swamp Lake Outlet, north side of County Road 80

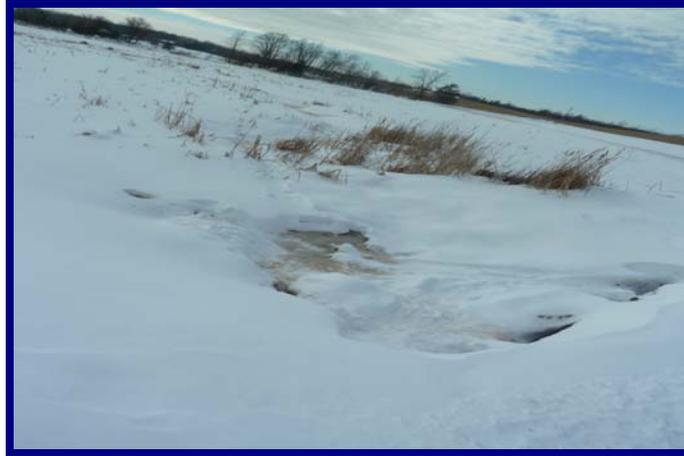
Swamp Lake Outlet, south side of County Road 80;
note open water area.

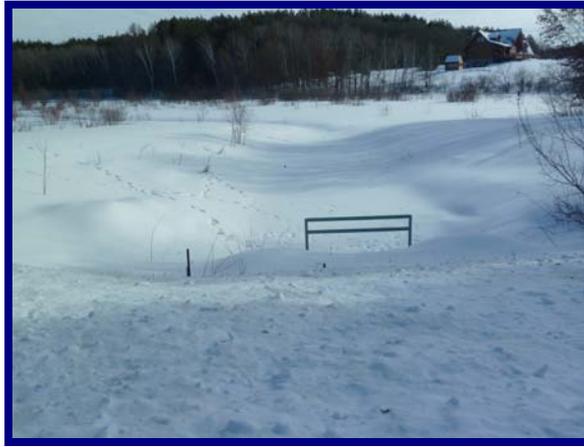
Ivywood Outlet Structure

The Ivywood Outlet structure, located on the east side of Ivywood Trail, was observed to be snow-covered. No apparent water flowage was seen. The channel located on the east side of Ivywood Trail was also observed to be snow-covered.

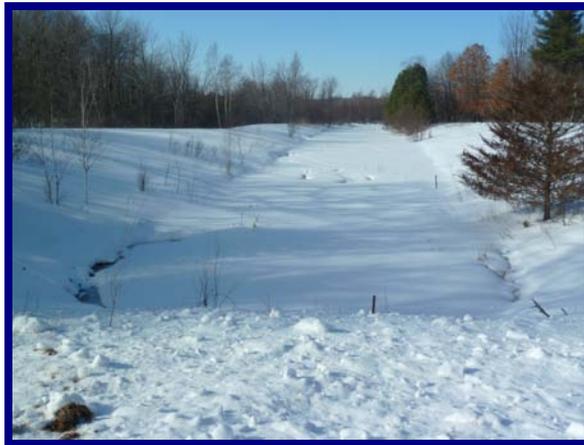
Channel located on the west side of Ivywood Trail.

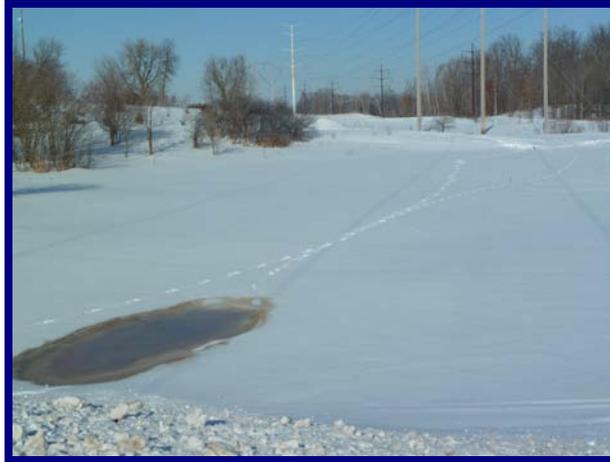
near the beaver dam located north of County Road 19; perhaps the landowner has removed a portion of the beaver dam.

North of County Road 19, open water flowing from culvert.

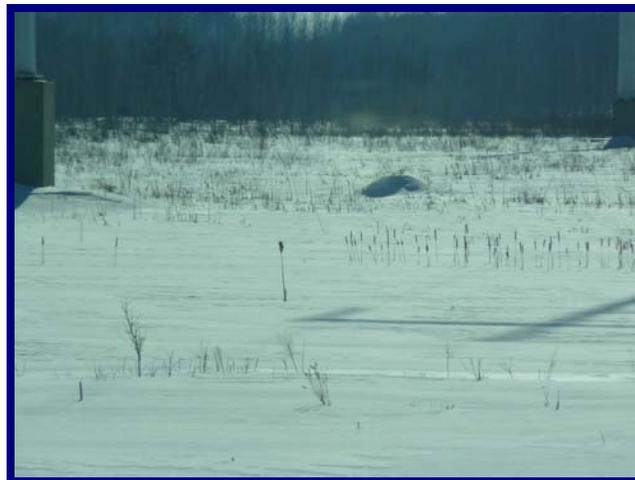
The Bloomquist Creek Crossing at County Road 19 was observed. Beaver dams have been noted here both north and south of County Road 19 this past fall. It is unclear if the beavers remain active in these locations at this time. County staff monitored the creek levels at this location up until surface freezing of the creek waters. County staff continues to keep watch on this area for beaver activity. Tracks and activity were noted

South of County Road 19, note raised beaver dam.
