**Date** | 10-29-2010

**To** | Chisago Lakes LID Board of Managers

**Regarding** | Fall Channel and Outlet Structure Inspection

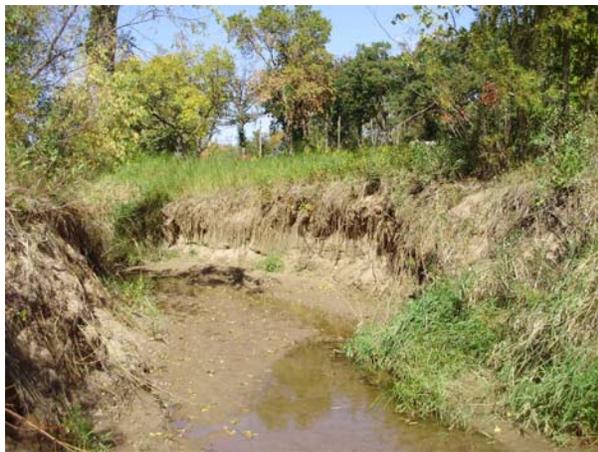
The entire length of the channel from Chisago Lake to Wallmark Lake was walked. Erosion in the channel near the connection with Chisago Lake has proceeded to occur since the last inspection. The channel has widened and bank failures continue to worsen. Plans for repair of this section have been prepared and initial meetings with the contractor and landowner have occurred. Repair of this section is scheduled for this fall. Additional construction materials and construction oversight is anticipated due to the increased failures that have occurred in this section. A delta is starting to form at the outlet of the channel due to erosion. The District may wish to consider having this delta removed.

Photos: left-exposed/eroding bank caused by head cut, delta at connection with Chisago Lake

- Proceed with fall project to repair erosion issues in the channel near Chisago Lake.
- Rearrange rip rap at box culvert outlet such that it is not obstructing upstream flows.
- Remove debris and logs at the Sportsman Drive Crossing
- Remove downed tree east of Lake Pointe Drive

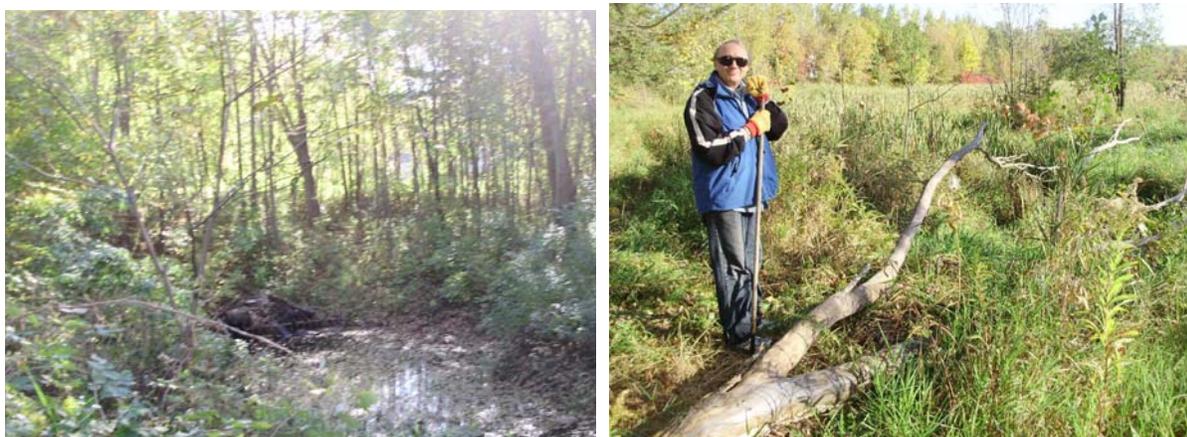
Just downstream of these areas is a large box culvert that flows under Stinson Avenue and Highway 8. At the down stream end of this pipe some of the large rock placed for erosion control purposes is currently sitting above the invert of the pipe. This may be obstructing some of the flows from upstream. The landowner at the upstream end of the box culvert is concerned about water levels and stormwater flowing towards Chisago Lake that he feels should be flowing out towards Wallmark Lake. Removal of this rock

North of North Avenue it was noted that several large branches had been placed across the channel to provide a crossing for a path from the nearby tot lot. The branches were removed from the channel as has been done on previous inspections. Because this appears to be an ongoing problem the LID has directed District Staff to work with the park owner to determine if a bridge should be placed at this location to allow for crossing the channel without placing obstructions in the channel. Discussions are ongoing.

Photos: left-rock placed above pipe invert, right-branches placed in channel

- Removed branches placed in channel
- Removed obstructions to culvert at Sportsman Drive Crossing
- Lopped off brush growing on overflow weir control structure

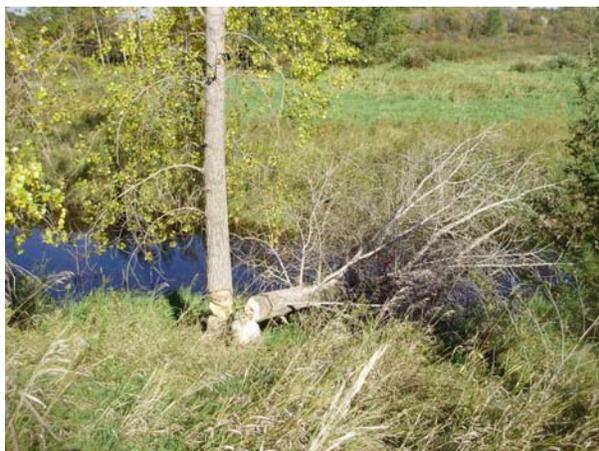
The entire length of the channel from Chisago Lake to Green Lake was walked. Between Chisago Lake and County Road 83 a beaver dam was observed that had been constructed since the last inspection. About midway between County Road 83 and the outlet structure going into Green Lake a large beaver dam was observed this dam was holding back approximately 2 feet of water. This dam was observed on the previous inspection. It is recommended that District staff coordinate with local trappers to have the beavers removed. Once the beavers are removed then the dams should be taken out. A couple trees had been taken down by beavers along the channel, one crossing the trail and one crossing the channel. These trees should be removed.

Photos: left-tree down in channel, right - new beaver dam near Chisago Lake

- Remove beavers prior to removal of beaver dams.
- Proceed with fall erosion maintenance project and include newly identified erosion area.
- Remove downed trees crossing the trail and channel

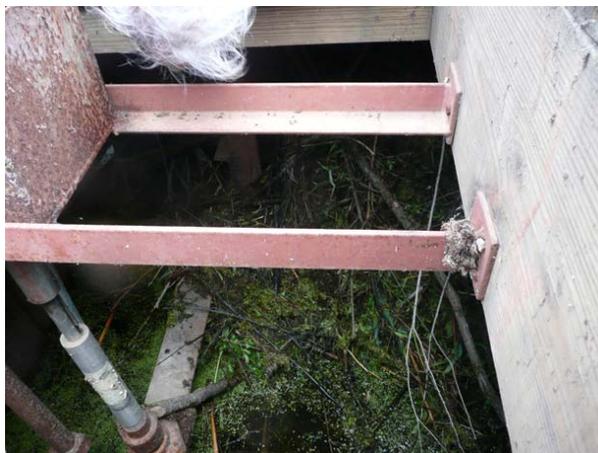
The outlet structure connecting the channel from Chisago Lake to Green Lake was visited. Branches were noted that appeared to be placed inside the weir structure by a beaver. At the time of the inspection the water levels were significantly higher on one side of the structure versus the back side of the structure that contains the outlet pipe. An attempt was made to open the gates separating the two areas to assure operation. The gates were difficult to operate and it was decided to hold off on forcing them open to avoid damage to mechanisms. Larry Rainer of the Highway Department was the person previously responsible for opening and closing the weirs. Larry Raineer and Jerry Spetzman visited the Lofton Avenue weir on October 25<sup>th</sup>. One side of the high water weir was clogged with beaver debris. They were able to open the other side of the weir and the outlet pipe to Green Lake. The water from the ponded area is draining into Green Lake. Lowering of the water level in the weir will facilitate beaver debris removal. Once the beaver debris is removed the gates should be returned to the closed position.

Photos: left-Branches inside of control structure, right-faded undertow sign

- Remove branches from overflow weir.

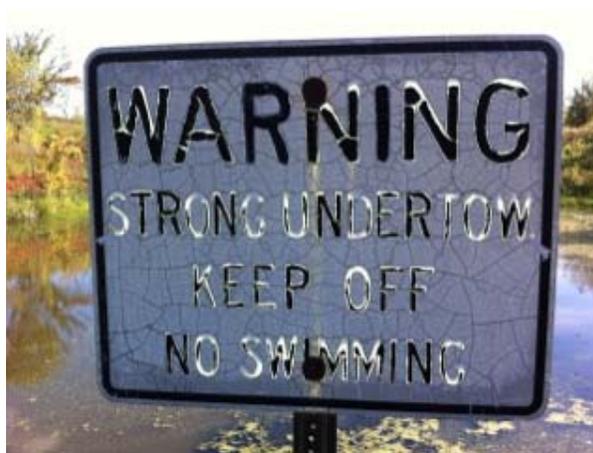
The undertow sign is in need of replacement. District Staff is in the process of ordering new signs for this weir and the Lake Ellen weir.

- Purchase or have another tool made for operating the control gates (currently there is only one tool between the two control structures). Engineer to obtain and review original project specifications for gate model, recommended maintenance practices and check on availability of a portable motorized tool for operating gates.
- Monitor site for continued beaver activity and need for beaver control.
- Replace faded undertow warning sign.

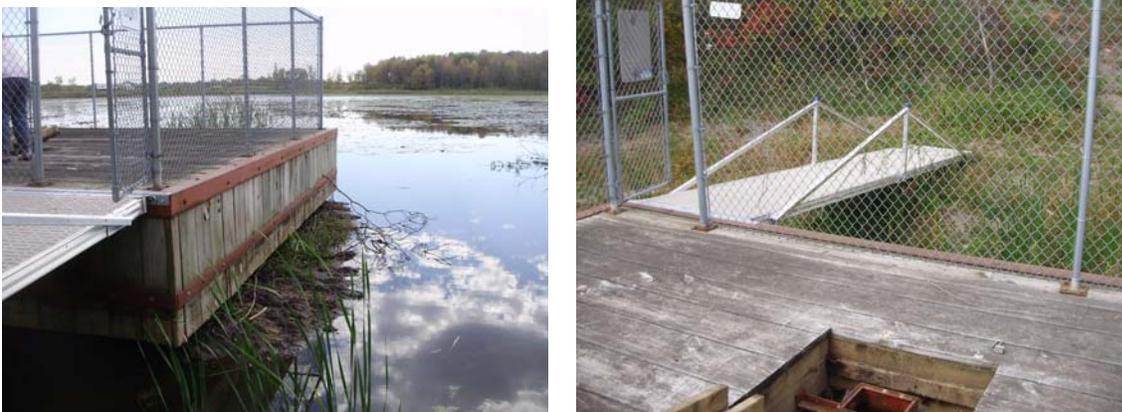
The outlet structure on Lake Ellen was visited. Debris was removed from around the Lake Ellen structure earlier this year. The gate was exercised and appeared to be operational. The emergency management plan calls for the gate to be open when the lake level is 891.5. The plan also says that the gate may remain closed when lake levels are below 891.0. Lake Ellen was at elevation 889.2 on 10/20/2010 per the District monitoring report, therefore the gate was left closed. It appeared that the Beavers might be rebuilding the dam around the outlet structure. This should be monitored and if this is the case, the beaver should be removed.

Photos: left-potential mud build up from beaver, right- new ramp replaced after last inspection

- Monitor Beaver Activity going forward and determine need for additional beaver control if beaver debris build-up continues to be a major problem at this location.
- Periodically exercise the gates to maintain them in working order.
- Purchase or have another tool made for operating the control gates (currently there is only one tool between the two control structures). Engineer to obtain tool cost information and also explore availability of powered tool for operating gates.
- Engineer to obtain and review plans and make recommendation for dewatering pipe prior to televising, if maintenance at Swamp Lake outlet does not sufficiently lower water levels.
- Order undertow warning sign similar to Lofton Avenue wier.

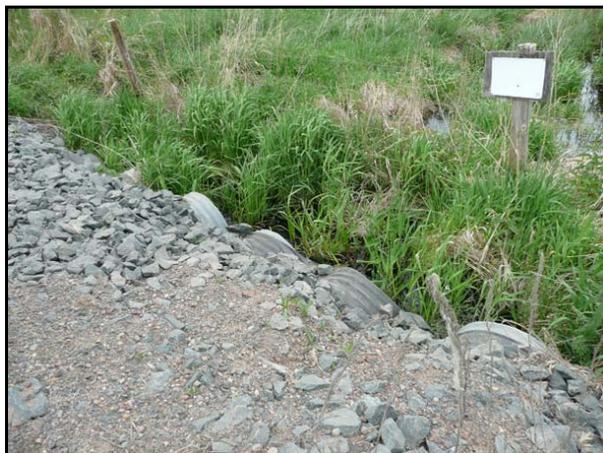
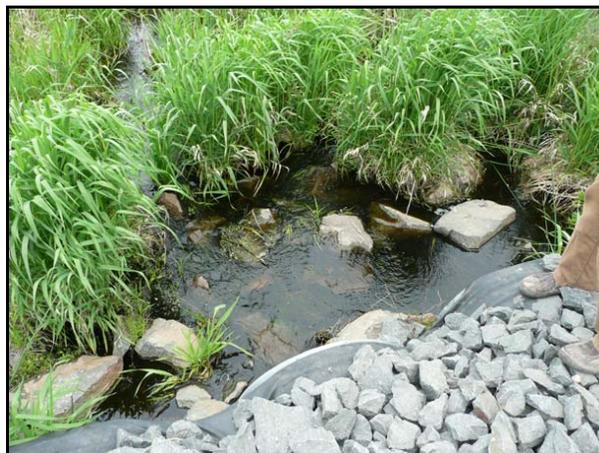
The Swamp Lake outlet pipes under County Road 80 were visited. This location has 7 pipes under the road to convey flow. Water was flowing at the time of the inspection. As noted during the previous inspection the pipes were partially filled with water due to rock and debris just downstream of the culverts that appeared to be obstructing some of the flow causing tailwater on the pipes. The water drop across the obstruction was estimated at about half a foot.

Photos: Outlet End of pipes leaving Swamp Lake

- Minor clean-out at outlet end of pipes and reconfigure rip rap.

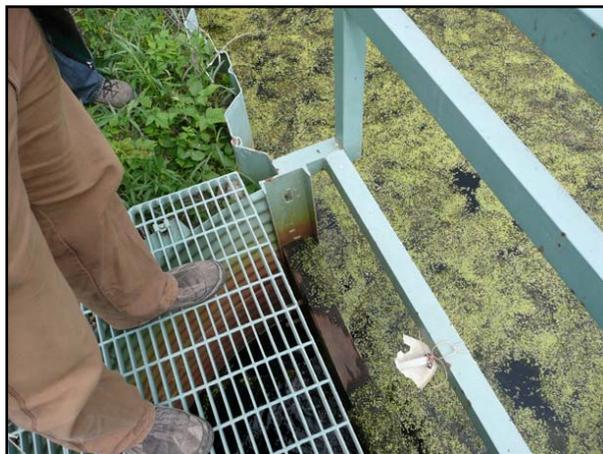
The culvert crossing under Ivywood Trail was visited. This structure does not provide any conveyance due to the outlet channel to Carlos Avery WMA never being completed.

No Action Needed.

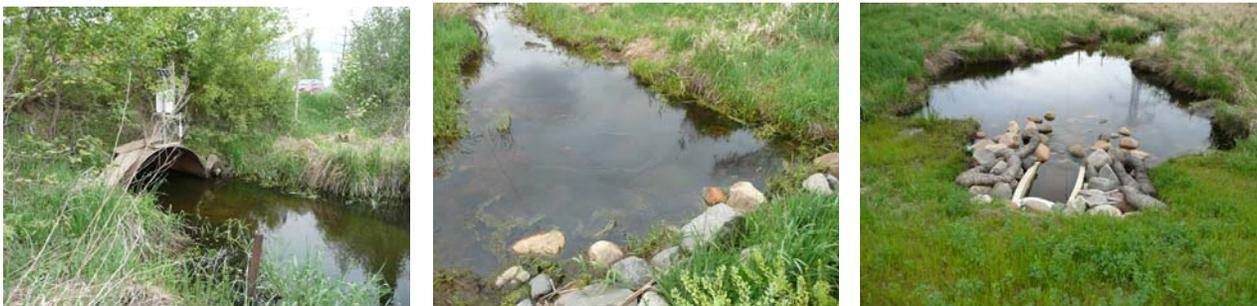
The Bloomquist Creek Crossing at Ivywood Trail was visited. Water was flowing through the stream and no maintenance issues were noted. The Bloomquist Creek Crossing at County Road 19 was also visited and water was flowing at this location also. The upstream end of the pipe was submerged as noted in the previous inspection report. It was unclear why the upstream end of this culvert was submerged and further investigation is warranted. Beaver dams both north and south of County Road 19 were reported by a landowner to District staff. District staff has indicated that the District likely does not have easements for these properties and landowner permission would be needed to remove these beaver dams. It is recommended that District staff follow up with landowner contact and if possible remove the beavers and then the dams.

Photos: Left-Bloomquist Creek Crossing @ Ivywood, Center-Upstream end of Bloomquist creek crossing @ CR 19, Right-Downstream end of crossing @ CR 19 (photos from previous inspection)

- Engineer to obtain plans for County Road 19 crossing to determine original design.
- Engineer to make recommendations for further action depending on the outcome of the design plan review.
- District staff to follow up with landowner contact and if possible remove the beavers and then the dams from the creek.
