# NELSON COURT SHORELINE

## SHORELINE STABILIZATION & PERVIOUS PAVEMENT

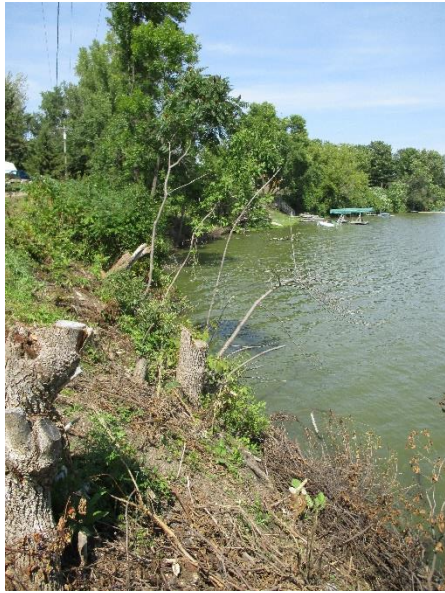
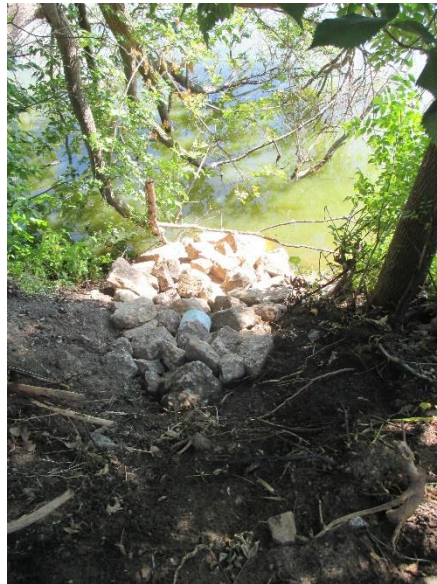
On the tiny strip of land that separates Pioneer and North Center Lakes, there was an eroding shoreline that deposited tons of sediment into Pioneer Lake. Pioneer Lake is impaired, meaning it does not meet water quality goals set by the State of Minnesota. Wave action and runoff accelerate the shoreline erosion. To stabilize the shoreline, brush bundles were created by the Minnesota Conservation Corps from buckthorn that was removed from the site. These brush bundles were anchored to the shoreline to break the waves. Behind the bundles and on the slope, the area was hydroseeded with grass species.

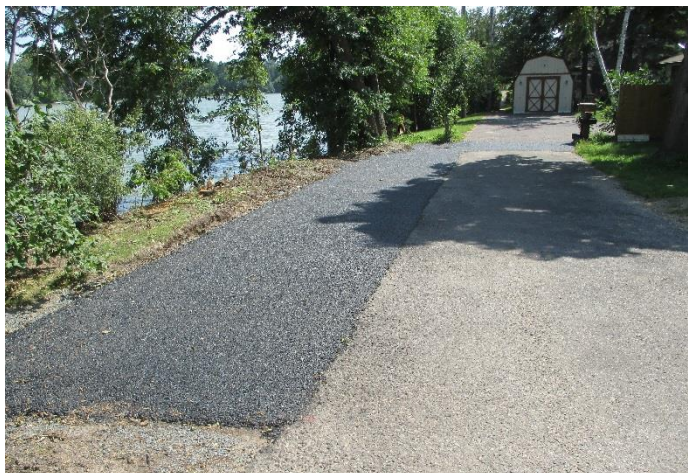
At the end of the road, there was a gully that carried the road runoff directly to the lake. This area was treated with pervious pavement and a new outlet structure. These projects will save over 5 pounds of phosphorus from entering the lake each year.
