**Date** | 10-29-2010

**To** | Chisago Lakes LID Board of Managers

**Regarding** | Fall Channel and Outlet Structure Inspection

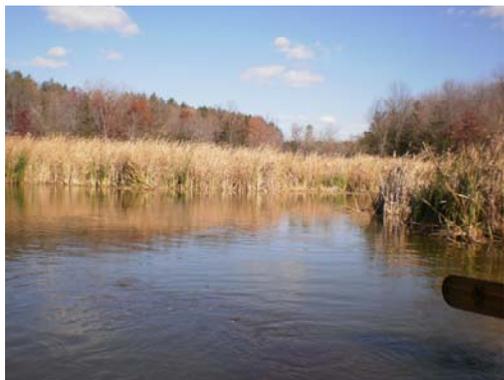
### Channel from Wallmark Lake to County Road 19

Jerry Spetzman and Greg Graske canoed to the outlet of Wallmark Lake. The outlet was undefined from the lake side with flow moving through the cattail mats to the outlet channel. In a follow up visit Mary Christopherson and Jerry Spetzman went to the house near the outlet of Wallmark Lake and got permission from the landowner to check the outlet channel. They made it to the halfway point between between the driveway and the location that was reached by canoe. There is a well constructed bridge across the channel that appears not to be used. No channel obstructions or beaver activity was found
