MINNESOTA AVENUE GULLY

GULLY STABILIZATION

A large actively eroding gully was stabilized with a rock lined channel on North Lindstrom Lake in August of 2016.

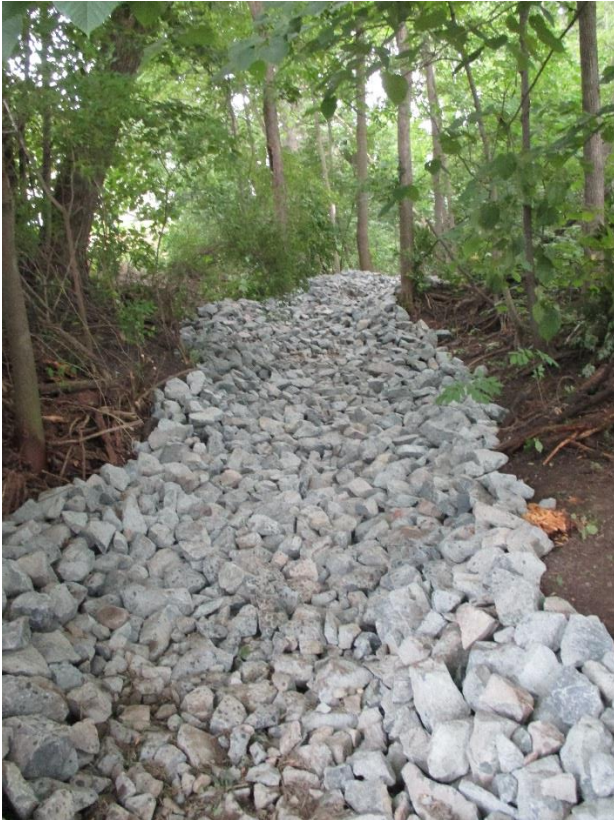
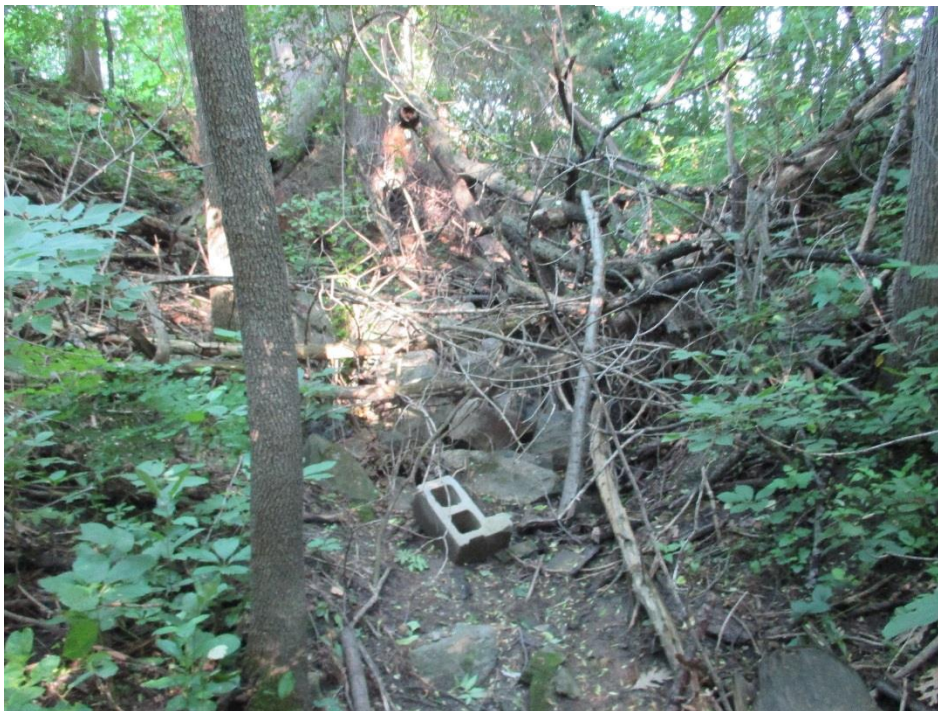
This gully runs directly into the lake without any treatment. The watershed includes a road, an agricultural field, woods, and lawns. Water will now travel more slowly through the rock lined channel as water must deflect and travel through the rocks. Erosion control fabric placed beneath the rocks will help protect the soil and prevent new erosion from occurring in the channel.
